## THERMOGRAPHY – BRUCITY EXAMPLE

Brucity is a new building that houses the administrative services of the City of Brussels since the end of 2022. Its insulation and energy efficiency are of a high standard. The building produces energy via photovoltaic panels and recovers thermal energy from sewage water to run its air conditioning system.

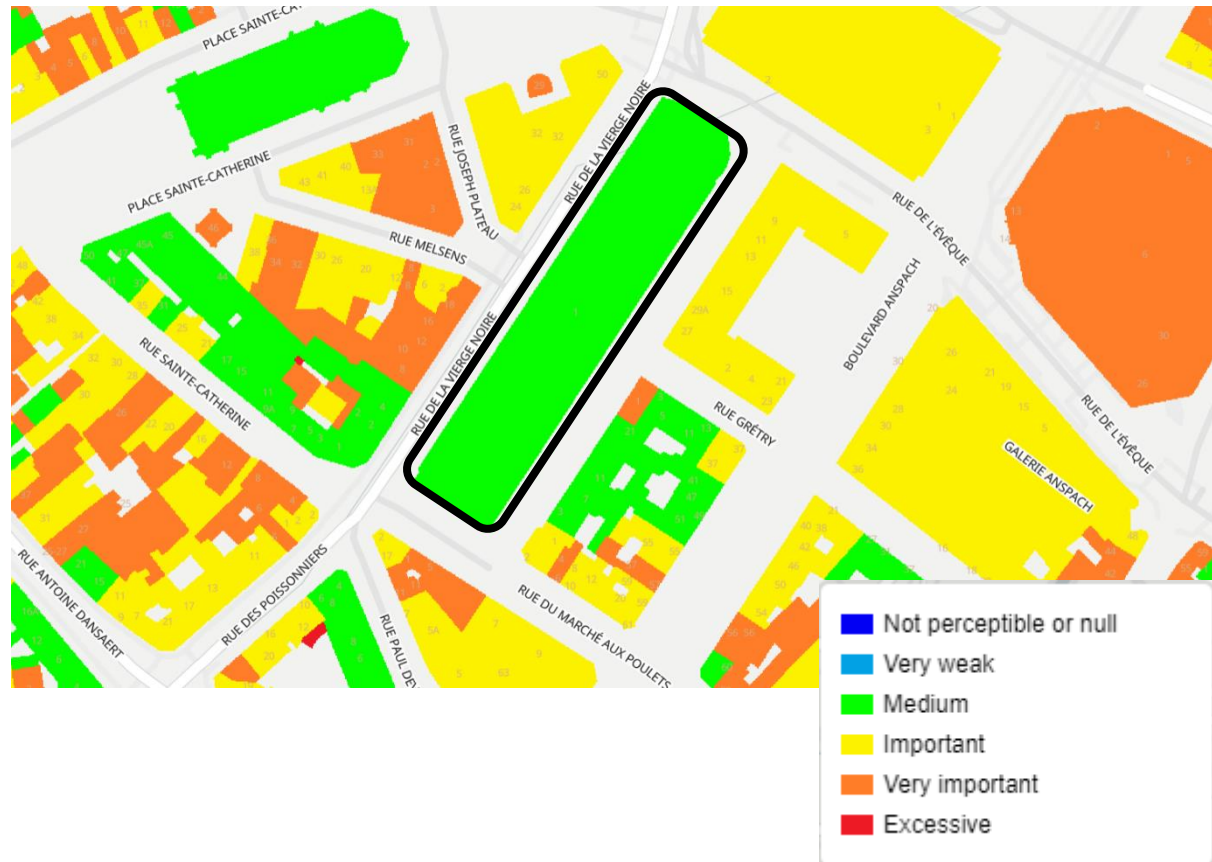
On the median layer (the predominant value observed on the roof), we see that the "Brucity" framed in black has green heat loss, i.e. average.

This is not a bad value, but given that this is a new building, we would expect a value closer to blue (very low heat loss). We therefore need to take a step-by-step approach to interpreting the data.

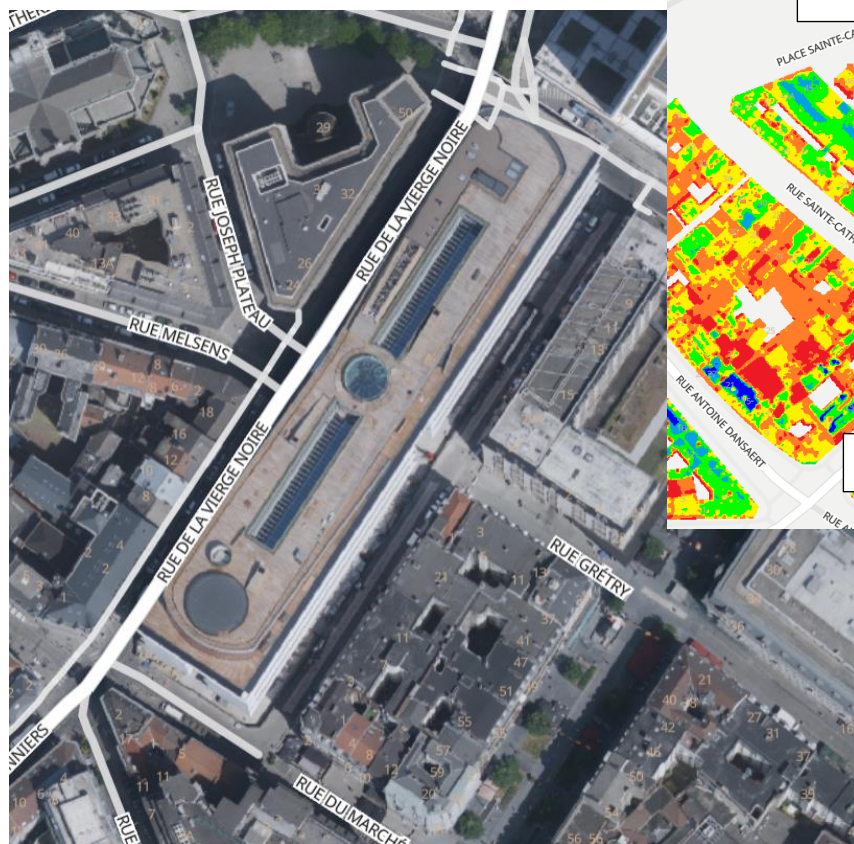
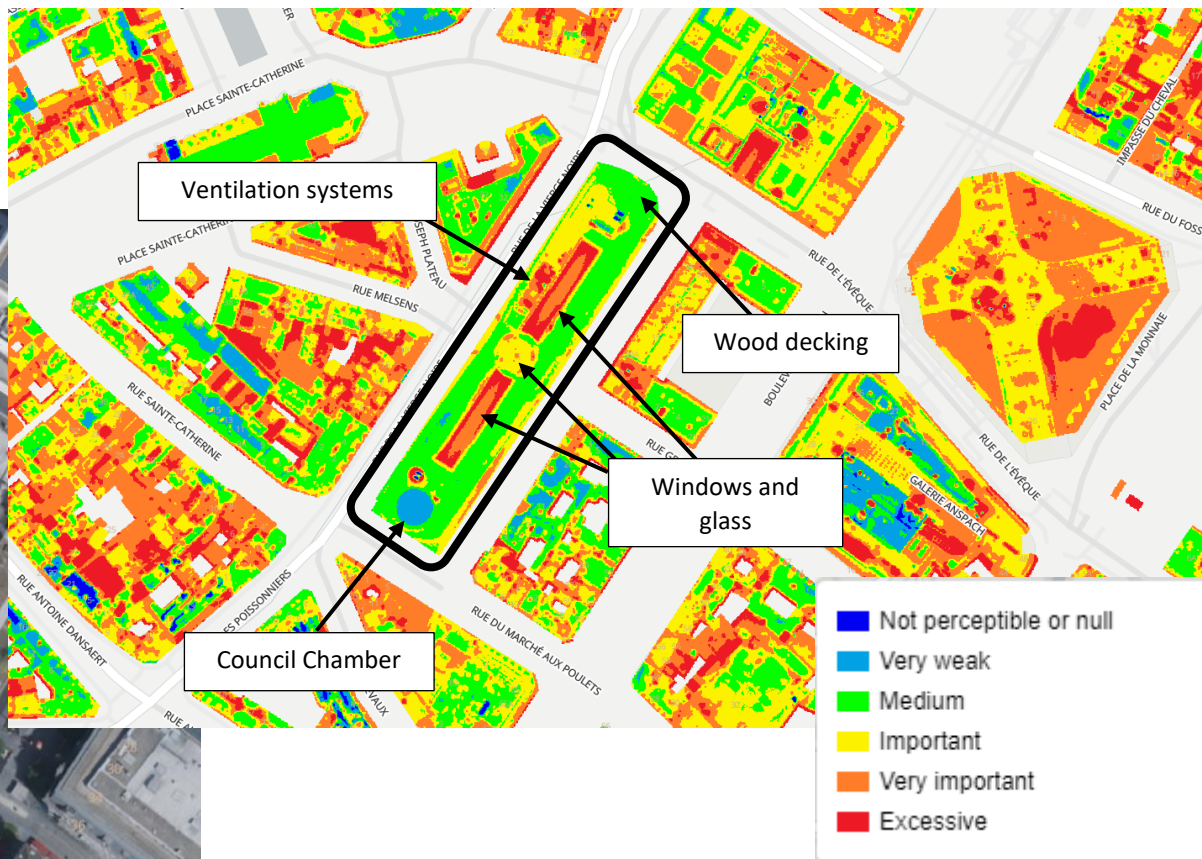
The global layer makes it possible to see, over the entire roof surface, the differences between the roof zones linked to the geometric elements and materials present on the surface.

- Most of the roof is green. The roof is covered by a wooden deck. Wood is a material that absorbs energy during the day, so this loss value is not representative of the overall insulation of the roof, because even if the roof is very well insulated under the wooden battens, which is the case for Brucity, the area will never appear blue on the thermograph.

- There are zones of glass and windows, such as the two atriums and the central area of the building, which allow light into the building. These areas are orange/red. This may indicate either significant solar reflectance/transmittance, which distorts the reading of heat loss, or greater heat loss than the rest of the roof.

- The area with the technical installations is orange/yellow, because there is heat loss via the pipes/extractors/VMC. This is normal, as the purpose of the pipes is to evacuate heat/ventilate the air. On the other hand, it can happen that a chimney is no longer used in a building. In such cases, this type of infrastructure can be a major source of unwanted heat leakage. In such cases, work can be undertaken to close and insulate the chimney.

- The rooftop/café area at the top left is yellow. We might think that this room is more heavily heated, or that the insulation is less effective than the rest of the building. In fact, it's a green roof, which has the same characteristics as wood (energy radiation). It is therefore not representative of the actual insulation underneath, and this data is not significant in terms of energy losses.

- The council chamber (small round roof bottom left) is shown in blue (very low energy loss) because this small roof is extremely well insulated, and perhaps also because this room was not heated at the time of the photo.
