POUR MOINS DE GASPILLAGE

THERMOGRAPHIE – EXEMPLE COMPLEXE SPORTIF NEDER-OVER-HEEMBEEK

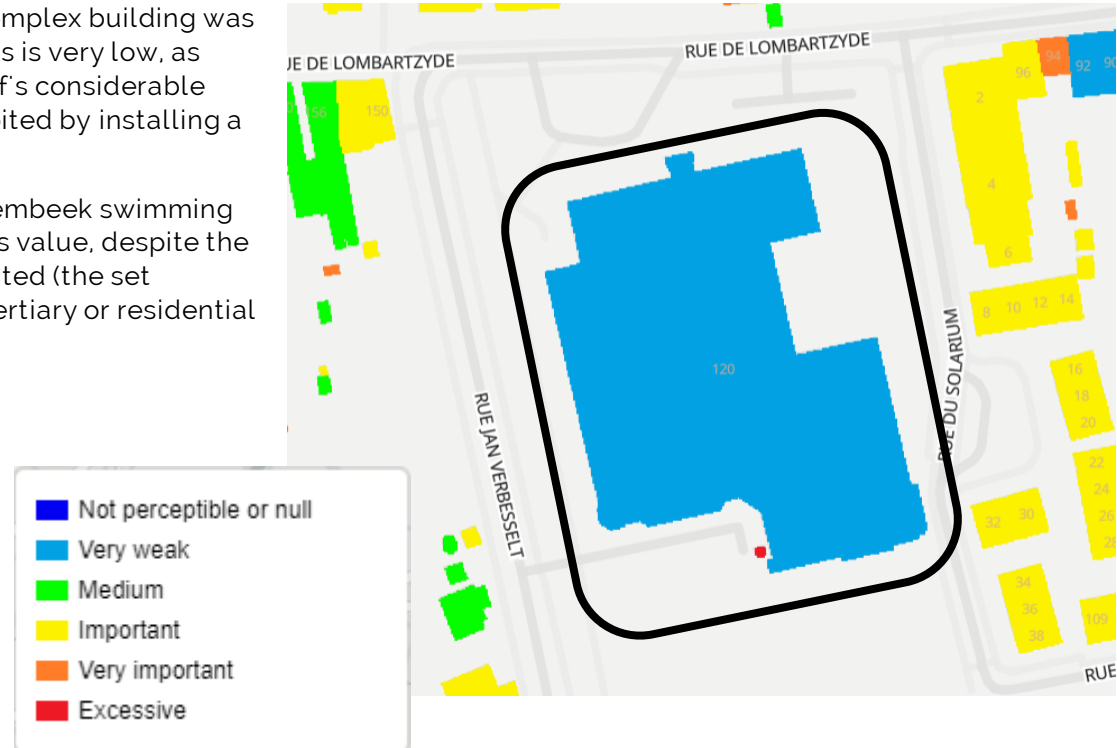
On the median layer, we can see that the Neder-Over-Heembeek swimming pool and sports complex have a very low median heat loss value, despite the age of the building and the fact that it is more heavily heated (the set temperature of a swimming pool is higher than that of a tertiary or residential building).

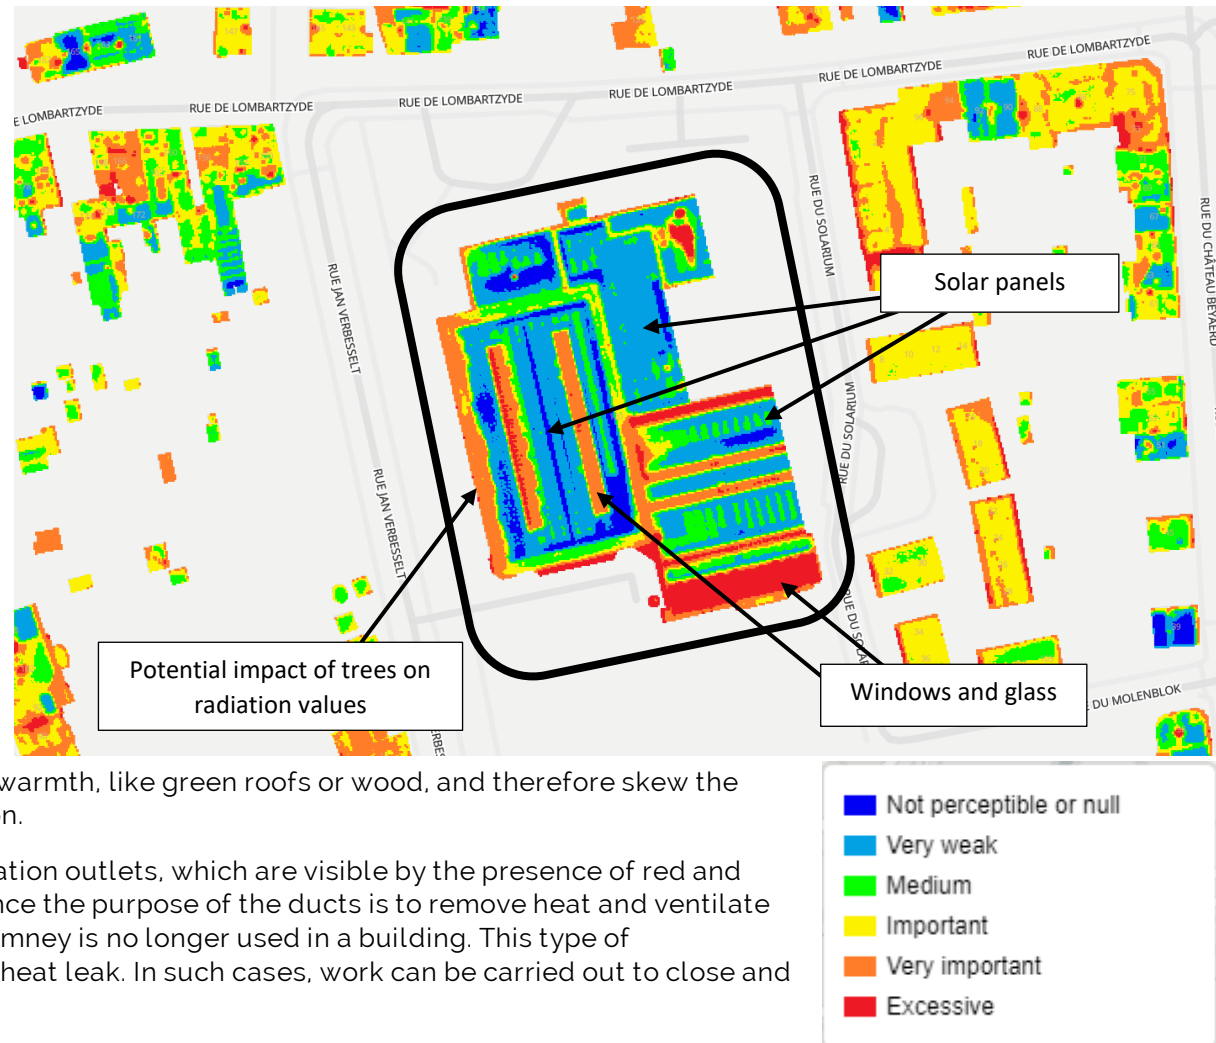
Looking at the overall layer, however, we can see that the levels of heat loss are not uniform.

Note the orange and red bands, which are linked in particular to the presence of large windows above the swimming pool and the multisports area, which may indicate losses (depending on the glazing) but also a reflectance/transmittance phenomenon.

Note also the impact on radiation of the solar panels (identifiable on the satellite photo below) installed on all the roofs of the sports complex, which can be seen in green and blue on the overall layer.

The presence of these materials with high reflectance / transmittance can skew the heat loss data, making it impossible to analyse the quality of the roof insulation using thermography.

Another effect affecting the reading of the roof is the presence of trees on the left-hand edge of the multi-sports area. Trees exude presence and warmth, like green roofs or wood, and therefore skew the results, which are not linked to poor roof insulation.

Finally, we can identify the locations of the ventilation outlets, which are visible by the presence of red and orange dots. This localised heat loss is normal, since the purpose of the ducts is to remove heat and ventilate the air. On the other hand, it can happen that a chimney is no longer used in a building. This type of infrastructure can then be a major and unwanted heat leak. In such cases, work can be carried out to close and insulate the chimney.
