## THERMOGRAPHY – EXAMPLE KINDERGARTEN HENRIETTE DACHSBEEK

The Henriette Dachsbeek kindergarten has been chosen as an example of the work that needs to be done to improve its energy efficiency. The school currently has an EPB E- and is part of the City of Brussels' public buildings renovation program, which will enable it to meet the energy performance targets set by the Region. The renovation is part of the overall "RenoClick" renovation program proposed by the Region to the public authorities. European funding may also be available to support the renovation.

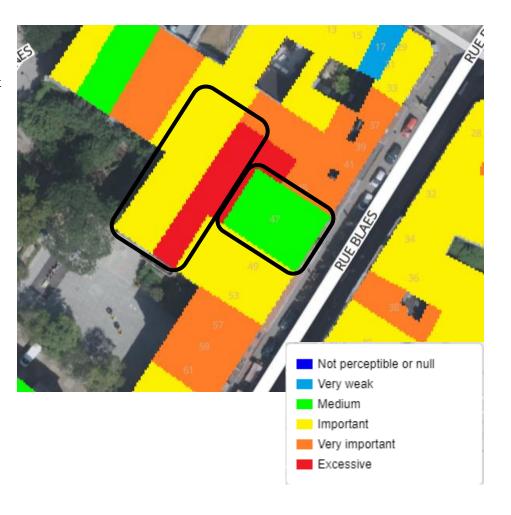
On the median layer (showing the overall roof score), we can see that the building facing the street has average heat loss, but that the buildings behind the courtyard have significant heat loss. The courtyard itself appears in red (due to its high thermal inertia).

Analysis of the median layer provides general information on the state of the roof on the three buildings that make up the nursery school. This general information needs to be cross-referenced with information on use and technical knowledge of the building, to enable targeted renovation of its weak points.

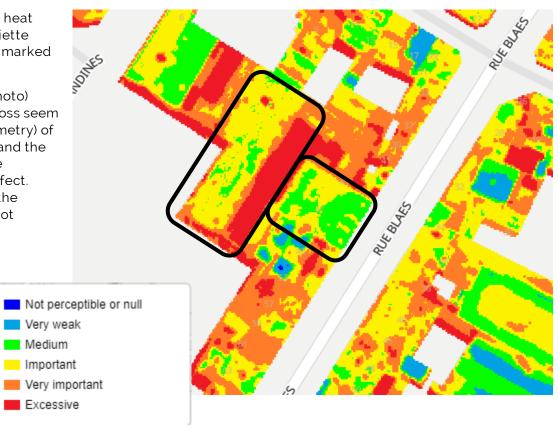
On the "global" layer, we can see a mixture of yellow (high heat loss) and green (medium heat loss) on the roof of the Henriette Dachsbeck nursery school, with the courtyard very clearly marked in red between the two buildings.

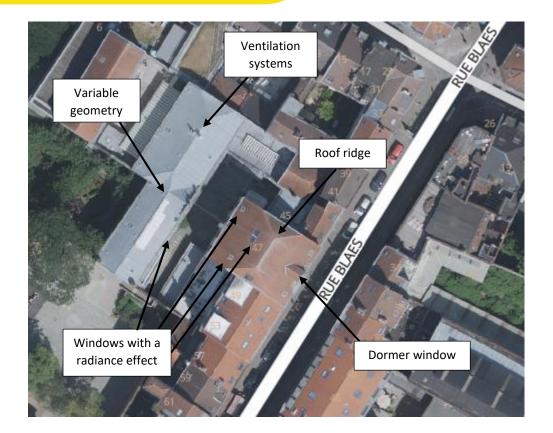
Comparing with an aerial photo (or orthophoto, satellite photo) such as the one below shows that the differences in heat loss seem to be linked to thermal bridges created by the shape (geometry) of the roof, in particular a dormer window (two yellow lines) and the ridge of the roof, which are sources of heat loss; and to the presence of windows with a reflectance/transmittance effect. There is also a marked presence of ventilation systems in the backyard buildings, which create a red spot, but which is not necessarily problematic if these systems are in operation.
