POUR MOINS DE GASPILLAGE

THERMOGRAPHIE – EXEMPLE COMPLEXE SPORTIF NEDER-OVER-HEEMBEEK

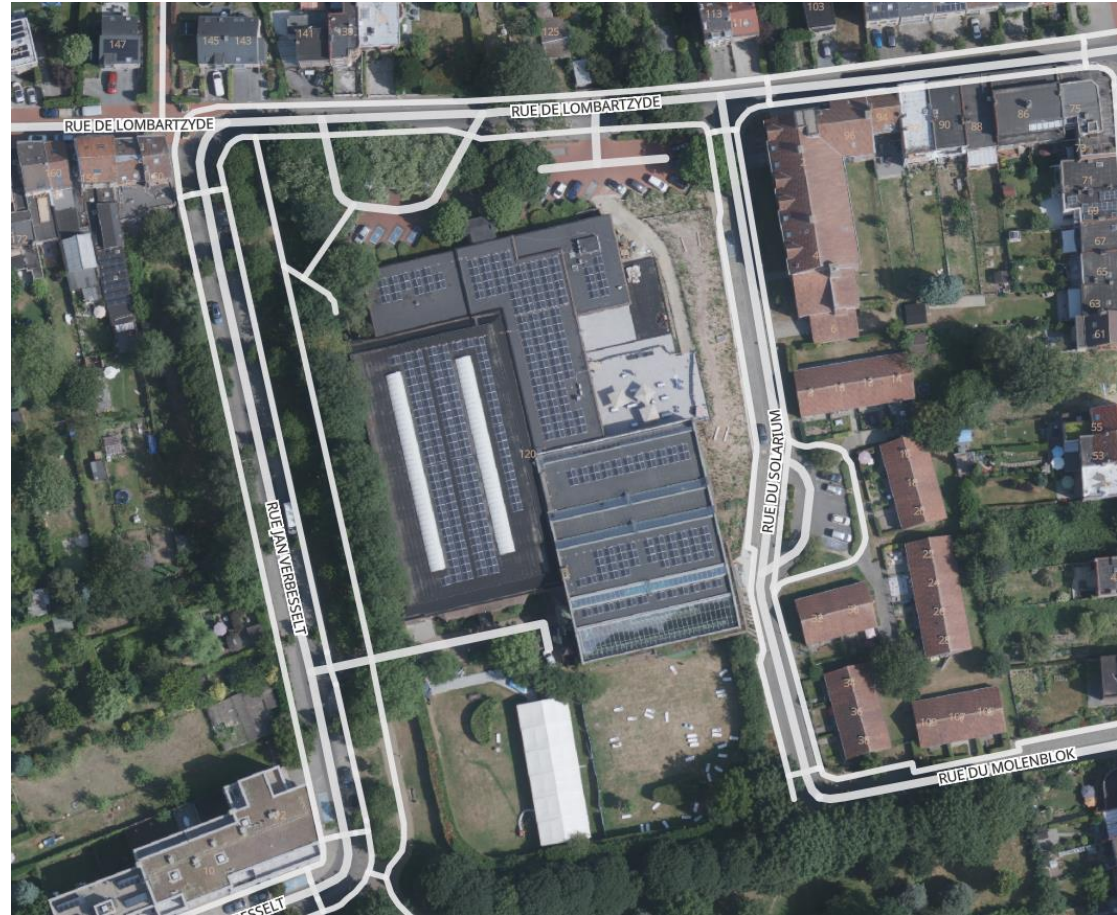
Looking at the overall layer, however, we can see that the levels of heat loss are not uniform.

Note the orange and red bands, which are linked in particular to the presence of large windows above the swimming pool and the multisports area, which may indicate losses (depending on the glazing) but also a reflectance/transmittance phenomenon.

Note also the impact on radiation of the solar panels (identifiable on the satellite photo below) installed on all the roofs of the sports complex, which can be seen in green and blue on the overall layer.

The presence of these materials with high reflectance / transmittance can skew the heat loss data, making it impossible to analyse the quality of the roof insulation using thermography.

Finally, we can identify the locations of the ventilation outlets, which are visible by the presence of red and orange dots. This localised heat loss is normal, since the purpose of the ducts is to remove heat and ventilate the air. On the other hand, it can happen that a chimney is no longer used in a building. This type of infrastructure can then be a major and unwanted heat leak. In such cases, work can be carried out to close and insulate the chimney.
